TAKOMA EDUCATIONAL CENTER

7010 Piney Branch Road, N.W., Washington, DC

CONDITION ASSESSMENT

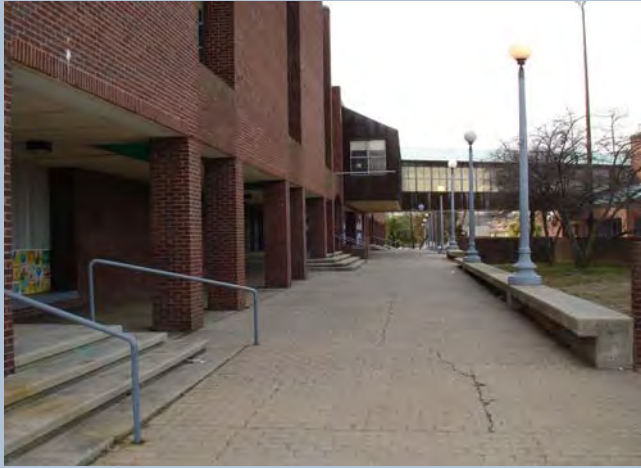
Building System	2008 Rating
ADA Compliance	Poor
Conveying Systems	Ok
Electrical	Fair
Exterior Finish	Fair
HVAC	Fair
Interior Finish	Good
Plumbing	Fair
Roof	Poor
Structure	Fair
Technology	Good
