HART MIDDLE SCHOOL

601 Mississippi Avenue, S.E., Washington, DC

CONDITION ASSESSMENT

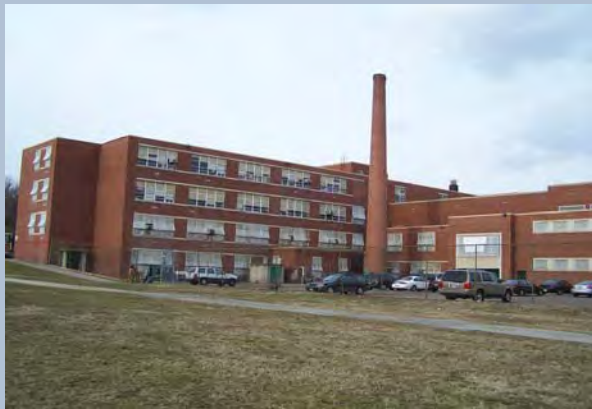
Building System	2008 Rating
ADA Compliance	Unsatisfactory
Conveying Systems	Unsatisfactory
Electrical	Good
Exterior Finish	Fair
HVAC	Fair
Interior Finish	Good
Plumbing	Fair
Roof	Fair
Structure	Fair
Technology	Good

1 Conveying System	There is no elevator, lift, or escalator present in the building.
2 Electrical	Electrical equipment is original and needs replacement. The fire alarm system is not code compliant; life safety systems do not meet code. The lighting quality is poor and all fixtures are antiquated and energy inefficient. 2007: Replaced exterior lighting. 2007: Lighting ballast and fixture replacement. 2008: New data out lets throughout new spaces. Installed new outlets to match data receptacles.
3 Exterior Finish	The brick veneer is in fair condition; repointing will be required. Several cracks in the brick veneer from the lack of control joints were also noted. Single pane windows in poor to unsatisfactory condition and should be replaced with modern windows. Security screens are in poor condition and should be repaired or replaced. Exterior trim should be cleaned and repainted. 2008: Window replacement 95% complete.

4 Structure	The concrete structure of the building appears to be in good condition. The brick at the top of the incinerator tower has major cracks and is a health safety risk.
5 HVAC	The steam heating system is functional, although only one of three boilers is operational. System is original. No overall cooling system exists-rooms cooled by window air conditioners. Building control system is obsolete. No existing roof mounted exhaust fans are operational. 2007: AHU repairs and heating system repairs. 2008: Repairs to boilers and classroom heating units. Installed 94 A/C window units and electrical upgrades.
6 Interior Finish	Asbestos floor tiles in most of building, a clear health safety issue. Moisture damage is apparent in one quarter of all ceiling tiles. Doors and door hardware in disrepair. Interior finishes are worn and should be entirely replaced. 2007: Partition and ceiling repairs, door frame, and hardware repair and replacement. 2008: Add new VCT replace in classrooms and corridors (as required), replace and repair doors and hardware as required. Replaced ACT.

7 Plumbing	Plumbing fixtures are in need of repair in many locations. Drinking fountains should be upgraded to ADA compliant models.
8 Roof	Roof is in fair condition overall with majority having about five years left before complete replacement will be required. A few isolated areas are in poor condition but can be remediate with minor maintenance and repair work.
9 ADA Compliance	Building is not ADA compliant. There are no handicapped accessible entrances, no accessible parking spaces, building egress paths are not accessible, there is no compliant elevator present, and bathrooms have non compliant fixtures.
10 Technology	LAN system not completed and has been dormant for several years. Many computers are older generation and should be replaced or upgraded. Other upgrades should include software, networking, and climate controlled spaces to house equipment. 2008: Two new computer labs, repaired IT wiring through out.

11 Grounds	Exterior site lighting is poor and many light fixtures do not work. No accessible entrances; Large limbs falling off of un-maintained trees creating a health safety issue. Paving at parking lot in poor condition; playground in poor condition.
