AITON ELEMENTARY SCHOOL

533 48th Place, N.E., Washington, DC

CONDITION ASSESSMENT

Condition Assessment

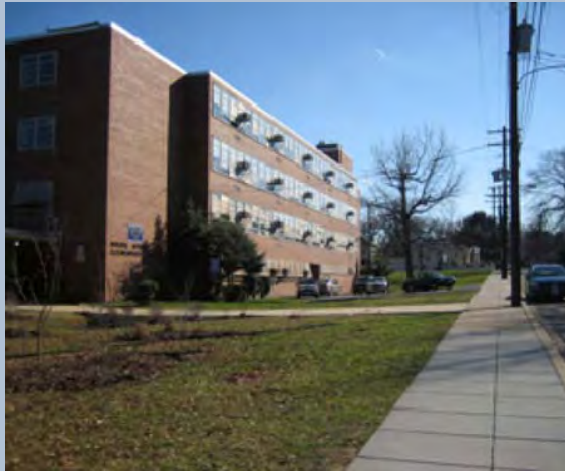
Building System	2008 Rating
ADA Compliance	Unsatisfactory
Conveying Systems	Unsatisfactory
Electrical	Fair
Exterior Finish	Fair
HVAC	Fair
Interior Finish	Fair
Plumbing	Fair
Roof	Poor
Structure	Good
Technology	Fair

These ratings reflect the overall condition and level of replacement need for an entire system, in adherence with the **Facility Condition Index (FCI) System**, categorizing systems as "Good" (FCI < .25), "Fair" (FCI 0.25 – 0.50), "Poor" (FCI 0.51 – 0.85), or "Unsatisfactory" (FCI > .86).

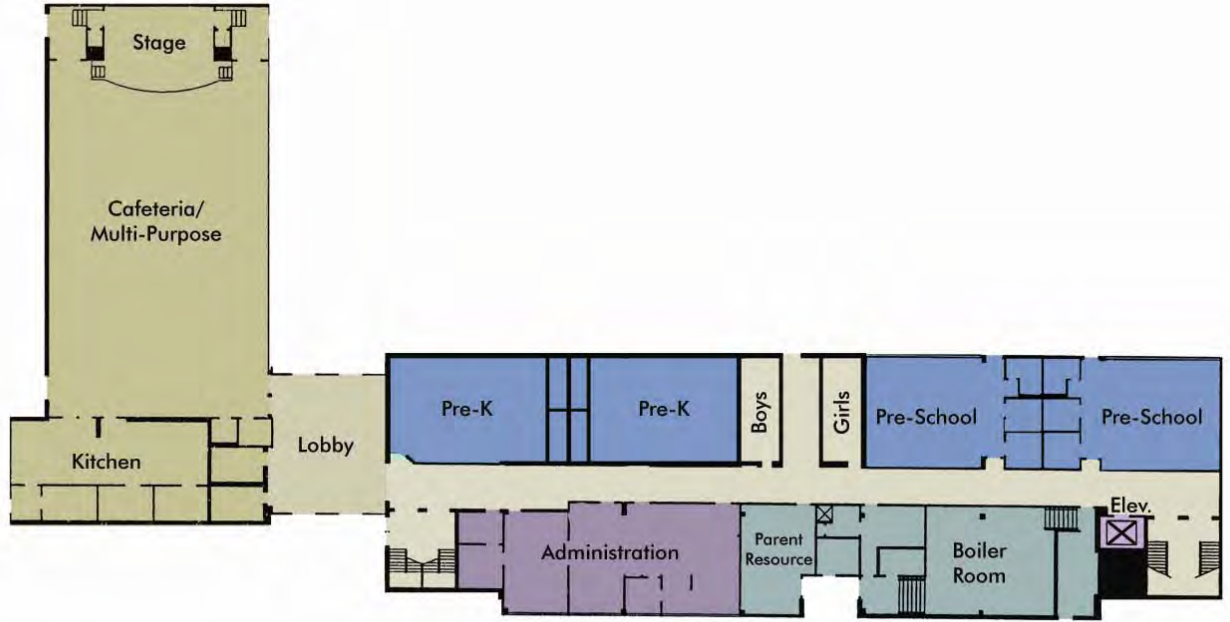
First Floor

These floor plans represent planning concepts for proposed facility use, aligning the proposed program capacity, the proposed planning profiles, and the conceptual reconfiguration of the building. Each project is subject to a formal design process, incorporating input from the School Improvement team at the time of project initiation.

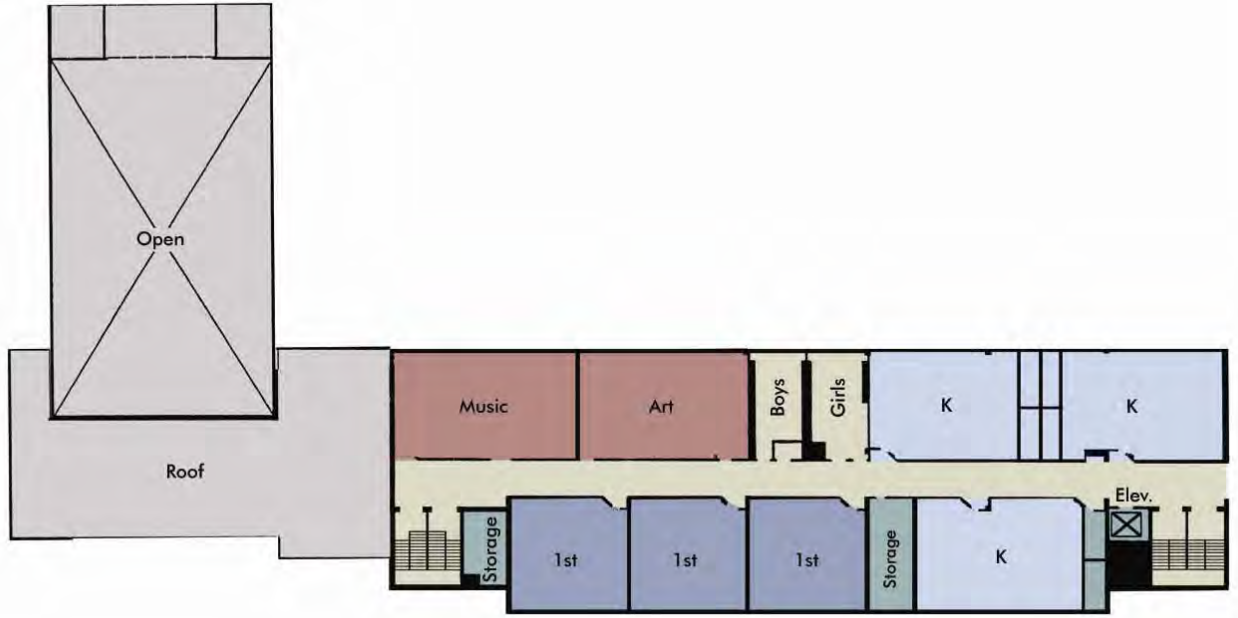
Second Floor

These floor plans represent planning concepts for proposed facility use, aligning the proposed program capacity, the proposed planning profiles, and the conceptual reconfiguration of the building. Each project is subject to a formal design process, incorporating input from the School Improvement team at the time of project initiation.

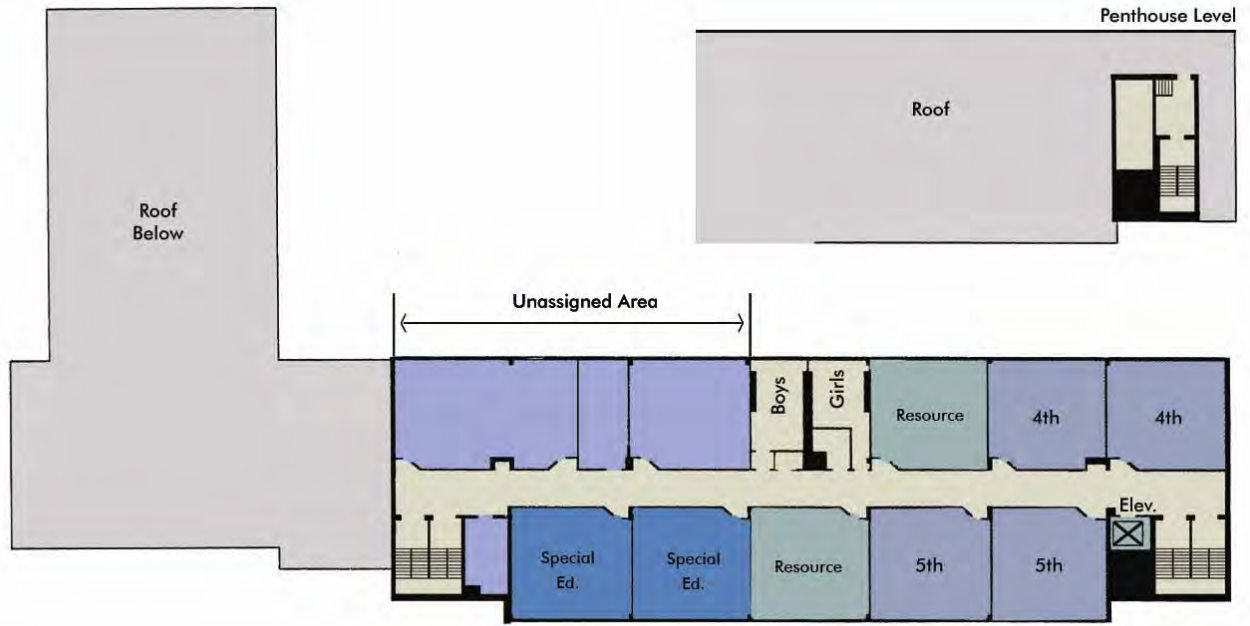
Fourth Floor

These floor plans represent planning concepts for proposed facility use, aligning the proposed program capacity, the proposed planning profiles, and the conceptual reconfiguration of the building. Each project is subject to a formal design process, incorporating input from the School Improvement team at the time of project initiation.
