BARNARD ELEMENTARY SCHOOL

430 Decatur Street, N.W., Washington, DC

CONDITION ASSESSMENT

Condition Assessment

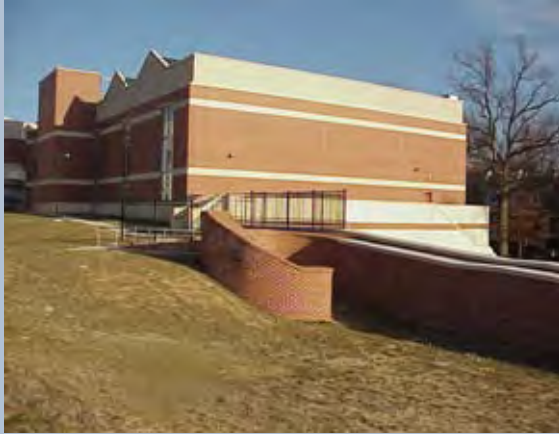
<i>Building System</i>	<i>2008 Rating</i>
ADA Compliance	Good
Conveying Systems	Good
Electrical	Good
Exterior Finish	Good
HVAC	Good
Interior Finish	Good
Plumbing	Good
Roof	Good
Structure	Good
Technology	Good

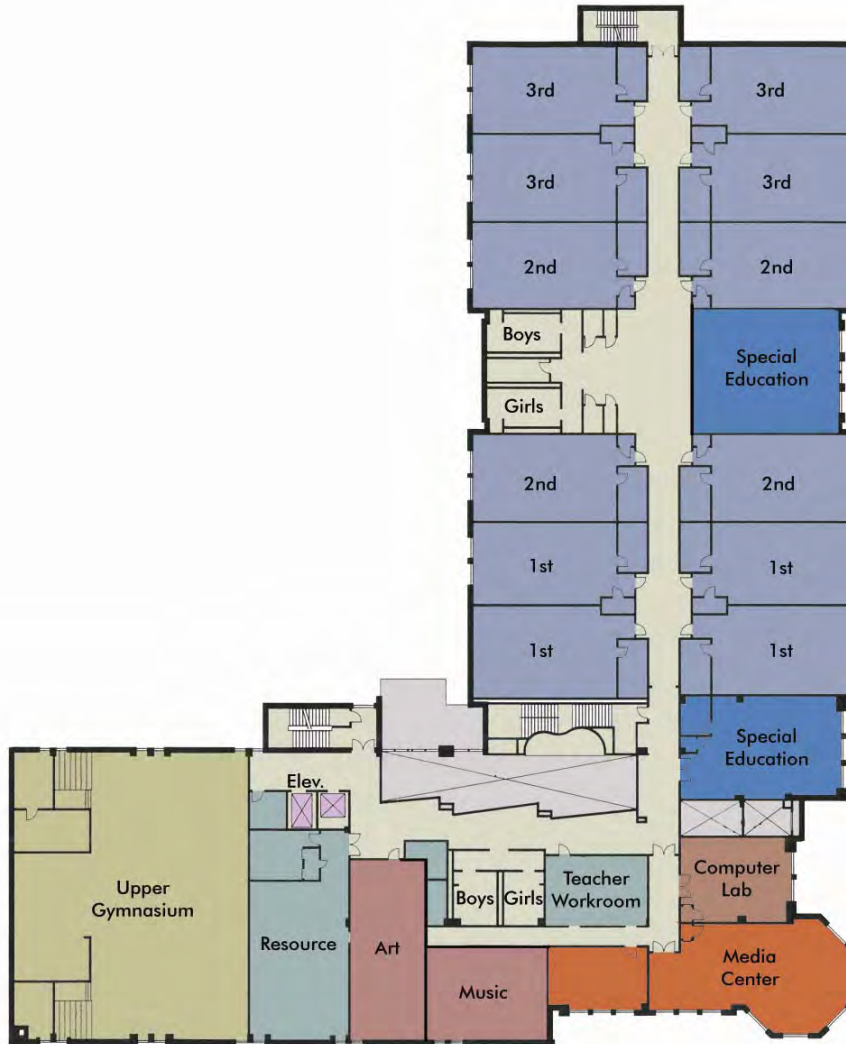
Second Floor

These floor plans represent planning concepts for proposed facility use, aligning the proposed program capacity, the proposed planning profiles, and the conceptual reconfiguration of the building. Each project is subject to a formal design process, incorporating input from the School Improvement team at the time of project initiation.
