# BROWNE EDUCATIONAL CENTER

850 26th Street, N.E., Washington, DC

## CONDITION ASSESSMENT

**Condition Assessment**

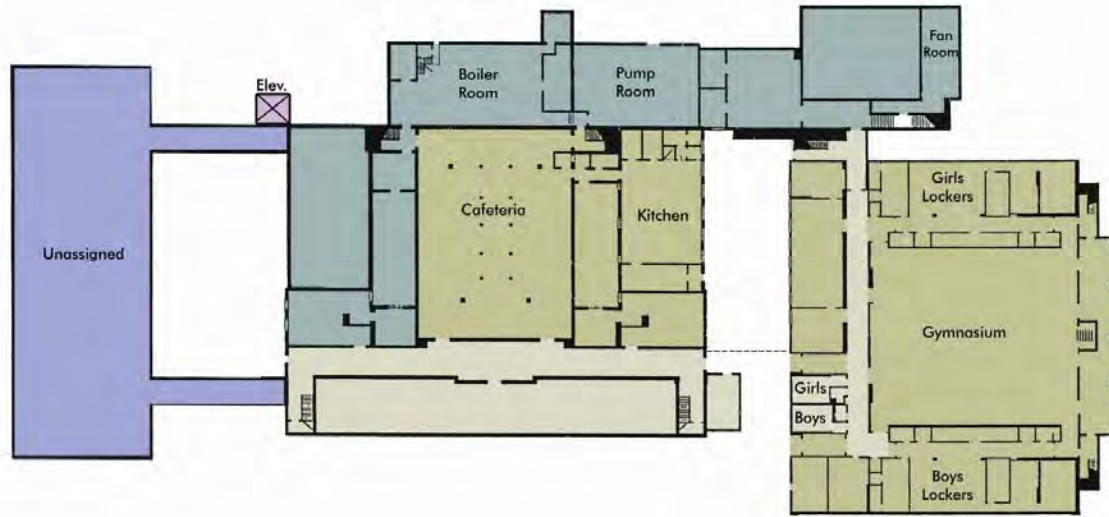
Basement

These floor plans represent planning concepts for proposed facility use, aligning the proposed program capacity, the proposed planning profiles, and the conceptual reconfiguration of the building. Each project is subject to a formal design process, incorporating input from the School Improvement team at the time of project initiation.

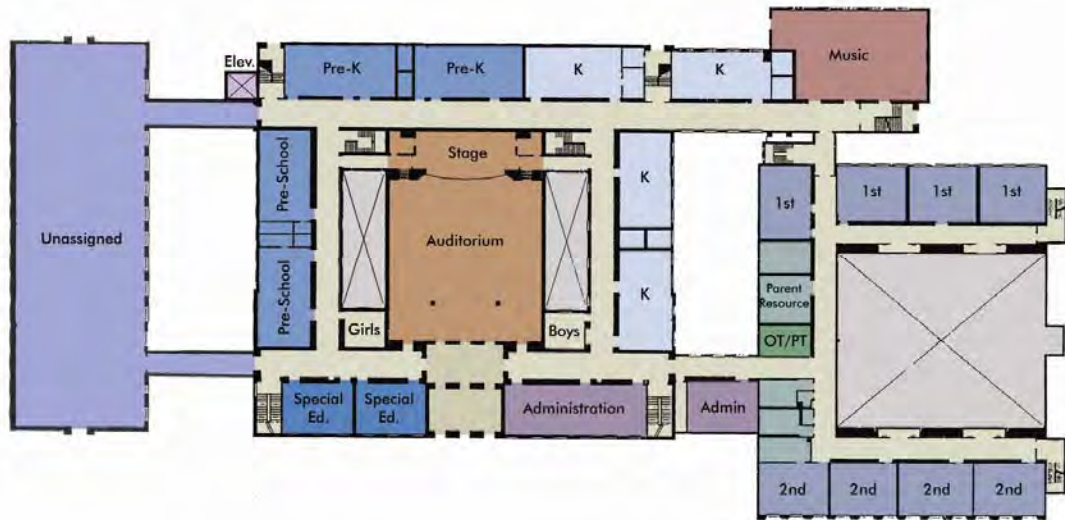
First Floor

These floor plans represent planning concepts for proposed facility use, aligning the proposed program capacity, the proposed planning profiles, and the conceptual reconfiguration of the building. Each project is subject to a formal design process, incorporating input from the School Improvement team at the time of project initiation.

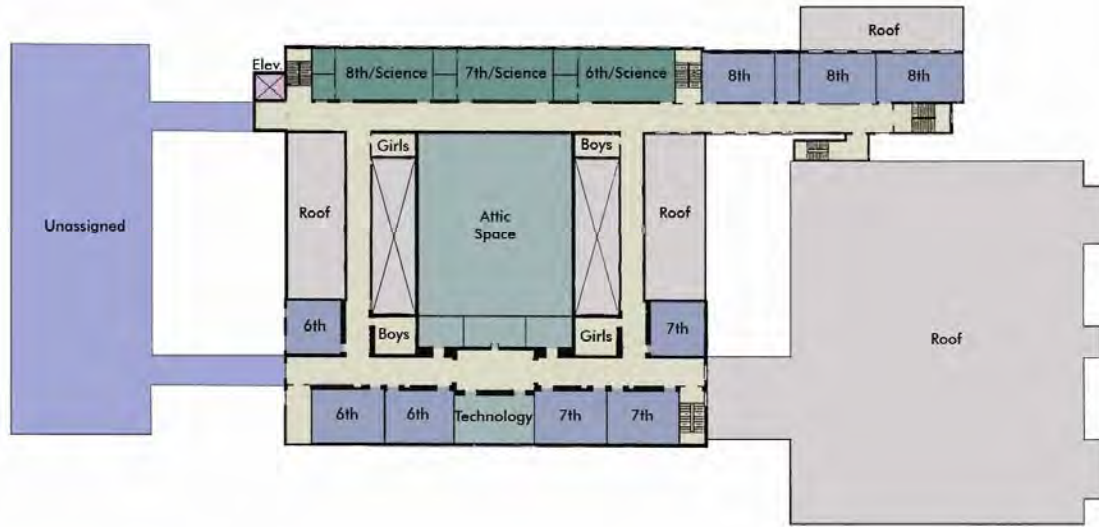
Third Floor

These floor plans represent planning concepts for proposed facility use, aligning the proposed program capacity, the proposed planning profiles, and the conceptual reconfiguration of the building. Each project is subject to a formal design process, incorporating input from the School Improvement team at the time of project initiation.
