# BUNKER HILL ELEMENTARY SCHOOL

## BROOKLAND AT BUNKER HILL ELEMENTARY SCHOOL

1401 Michigan Avenue, N.E., Washington, DC

### CONDITION ASSESSMENT

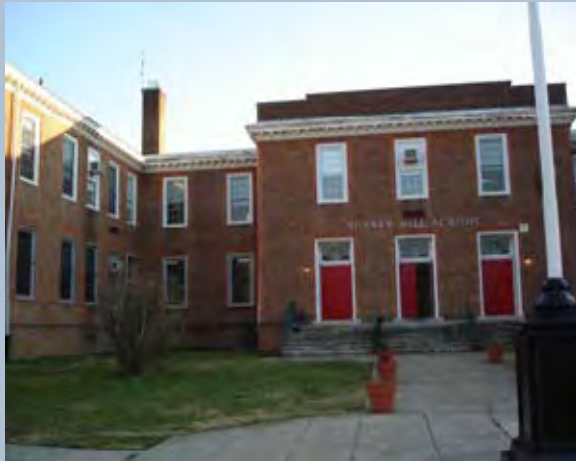
Building System	2008 Rating
ADA Compliance	Fair
Conveying Systems	Unsatisfactory
Electrical	Fair
Exterior Finish	Fair
HVAC	Fair
Interior Finish	Good
Plumbing	Fair
Roof	Good
Structure	Fair
Technology	Good

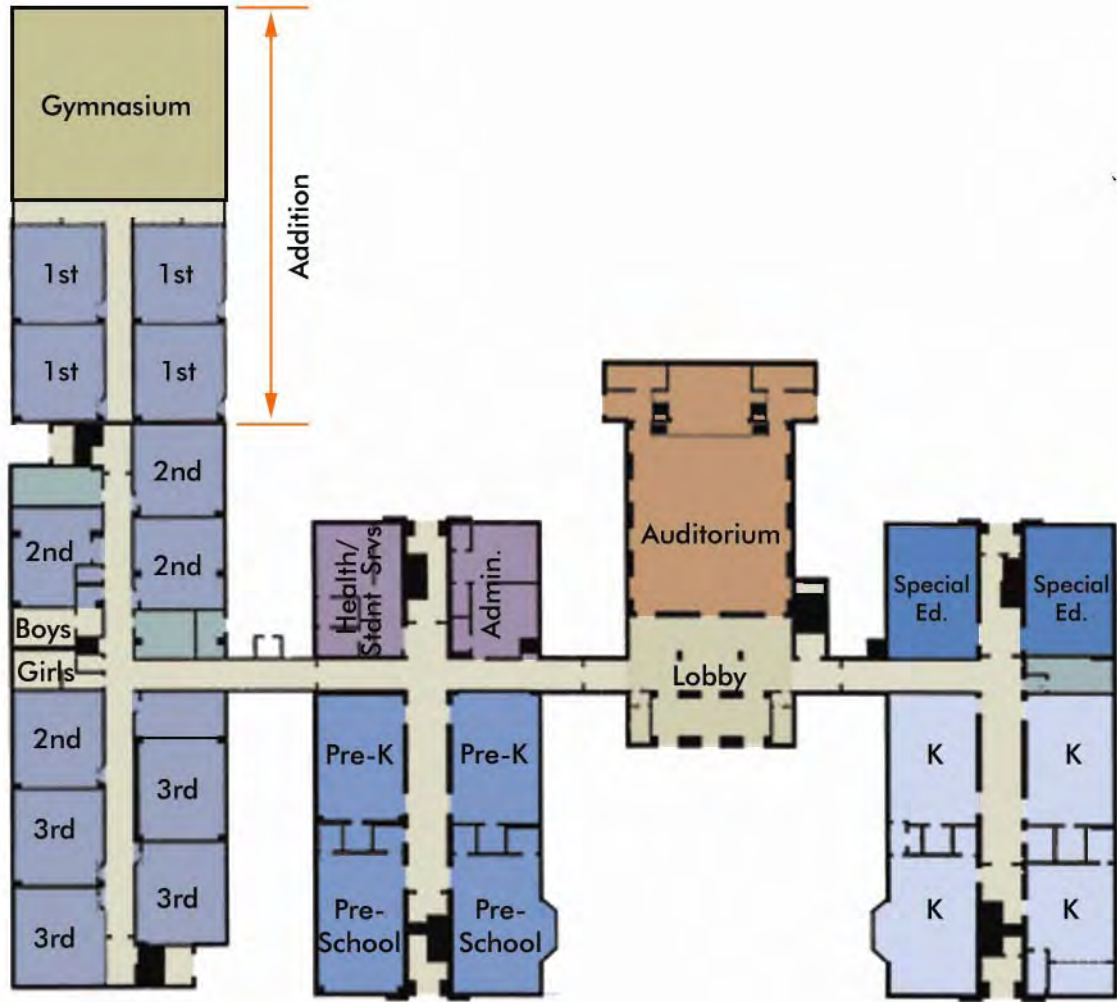
First Floor

These floor plans represent planning concepts for proposed facility use, aligning the proposed program capacity, the proposed planning profiles, and the conceptual reconfiguration of the building. Each project is subject to a formal design process, incorporating input from the School Improvement team at the time of project initiation.

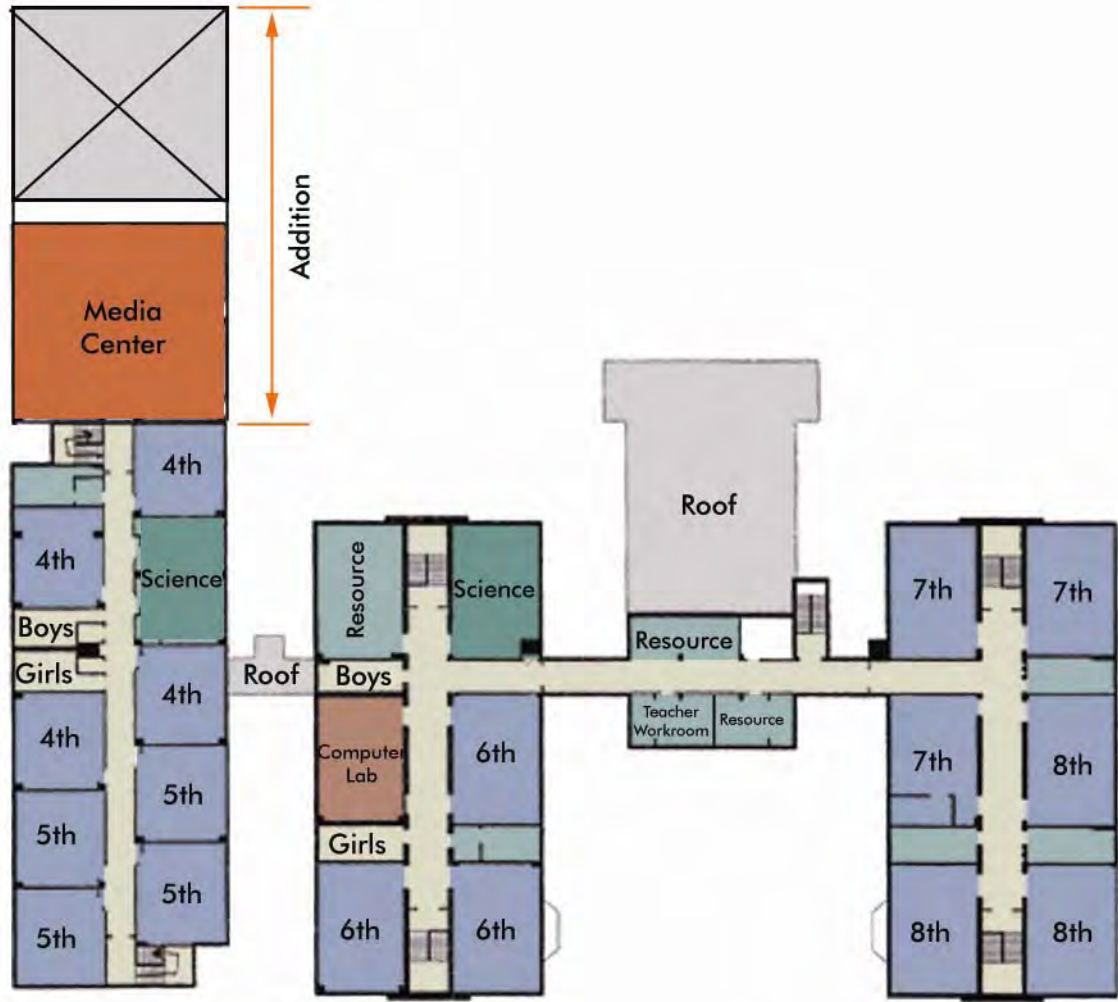
Second Floor

These floor plans represent planning concepts for proposed facility use, aligning the proposed program capacity, the proposed planning profiles, and the conceptual reconfiguration of the building. Each project is subject to a formal design process, incorporating input from the School Improvement team at the time of project initiation.
