KENILWORTH ELEMENTARY SCHOOL

1300 44th Street, S.E., Washington, DC

CONDITION ASSESSMENT

Condition Assessment

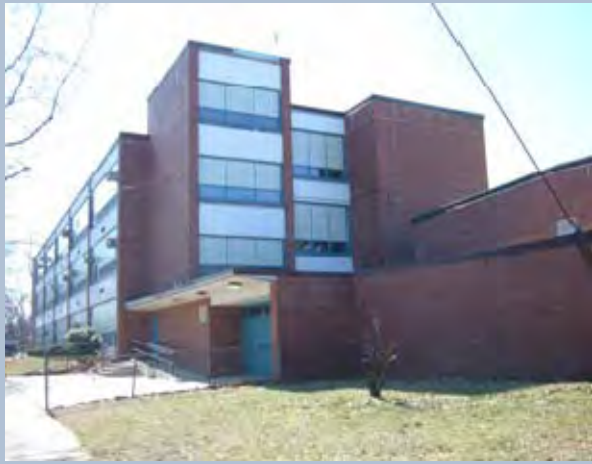
Building System	2008 Rating
ADA Compliance	Unsatisfactory
Conveying Systems	Unsatisfactory
Electrical	Poor
Exterior Finish	Poor
HVAC	Poor
Interior Finish	Fair
Plumbing	Poor
Roof	Good
Structure	Fair
Technology	Fair

Condition Scorecard

These ratings reflect the overall condition and level of replacement need for an entire system, in adherence with the **Facility Condition Index (FCI) System**, categorizing systems as "Good" (FCI < .25), "Fair" (FCI 0.25 – 0.50), "Poor" (FCI 0.51 – 0.85), or "Unsatisfactory" (FCI > .86).

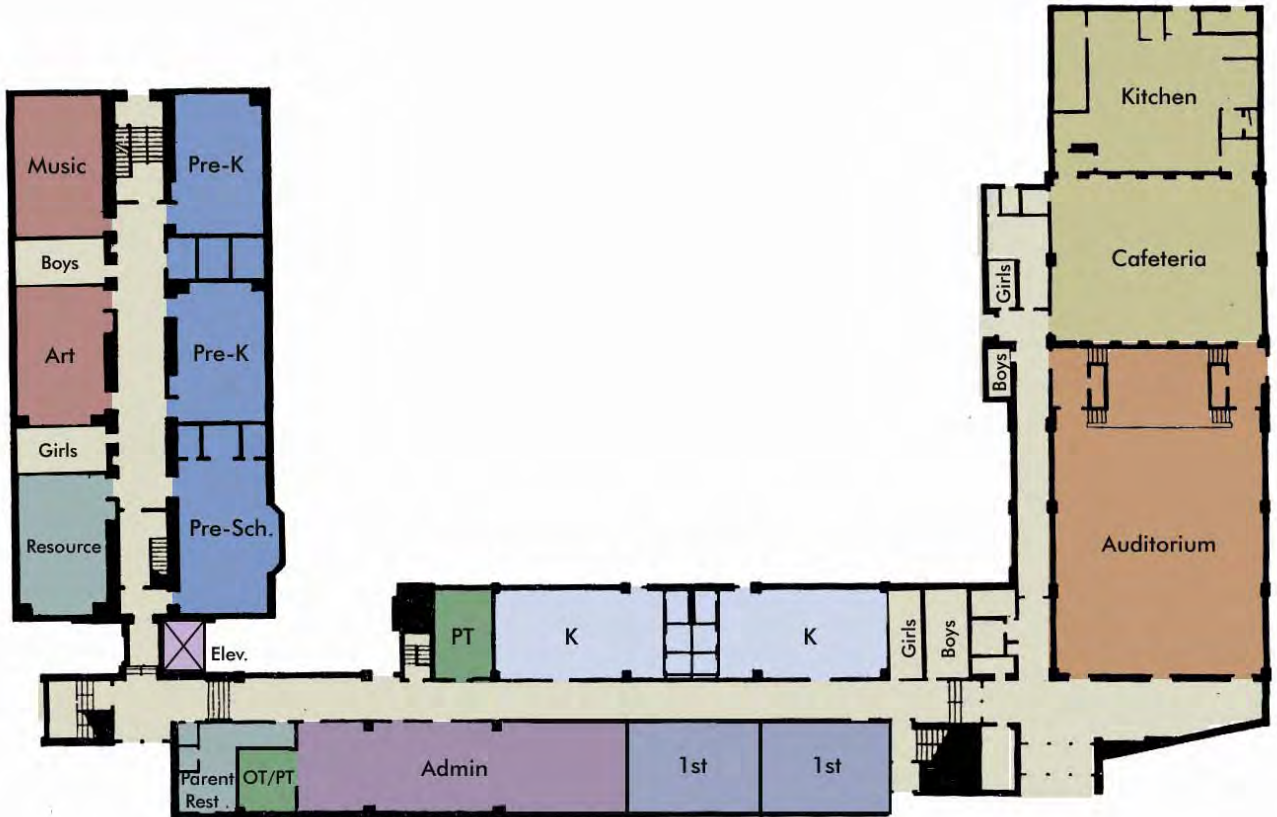
First Floor

These floor plans represent planning concepts for proposed facility use, aligning the proposed program capacity, the proposed planning profiles, and the conceptual reconfiguration of the building. Each project is subject to a formal design process, incorporating input from the School Improvement team at the time of project initiation.

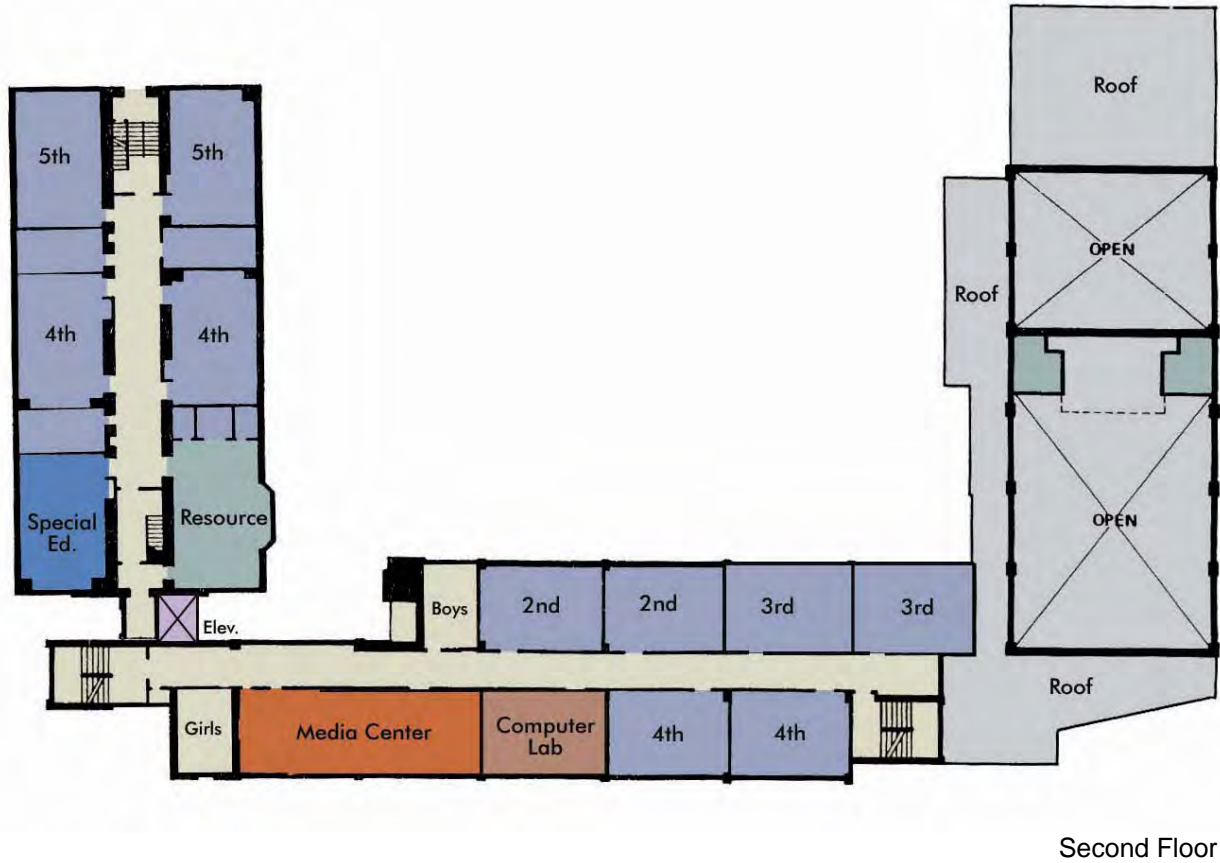
These floor plans represent planning concepts for proposed facility use, aligning the proposed program capacity, the proposed planning profiles, and the conceptual reconfiguration of the building. Each project is subject to a formal design process, incorporating input from the School Improvement team at the time of project initiation.
