MONTGOMERY ELEMENTARY SCHOOL

421 P. Street, N.W., Washington, DC

CONDITION ASSESSMENT

Condition Assessment

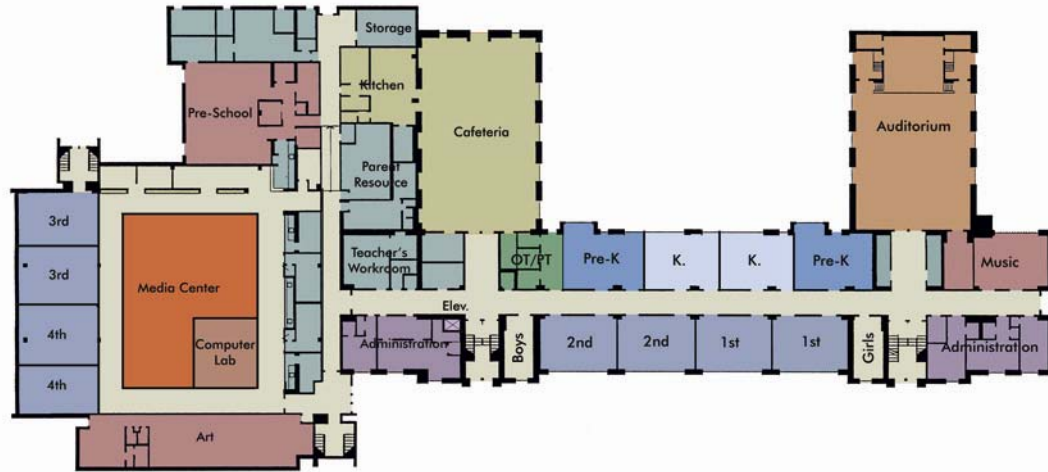
First Floor

These floor plans represent planning concepts for proposed facility use, aligning the proposed program capacity, the proposed planning profiles, and the conceptual reconfiguration of the building. Each project is subject to a formal design process, incorporating input from the School Improvement team at the time of project initiation.
