POWELL ELEMENTARY SCHOOL

1350 Upshur Street, N.W., Washington, DC

CONDITION ASSESSMENT

Condition Assessment

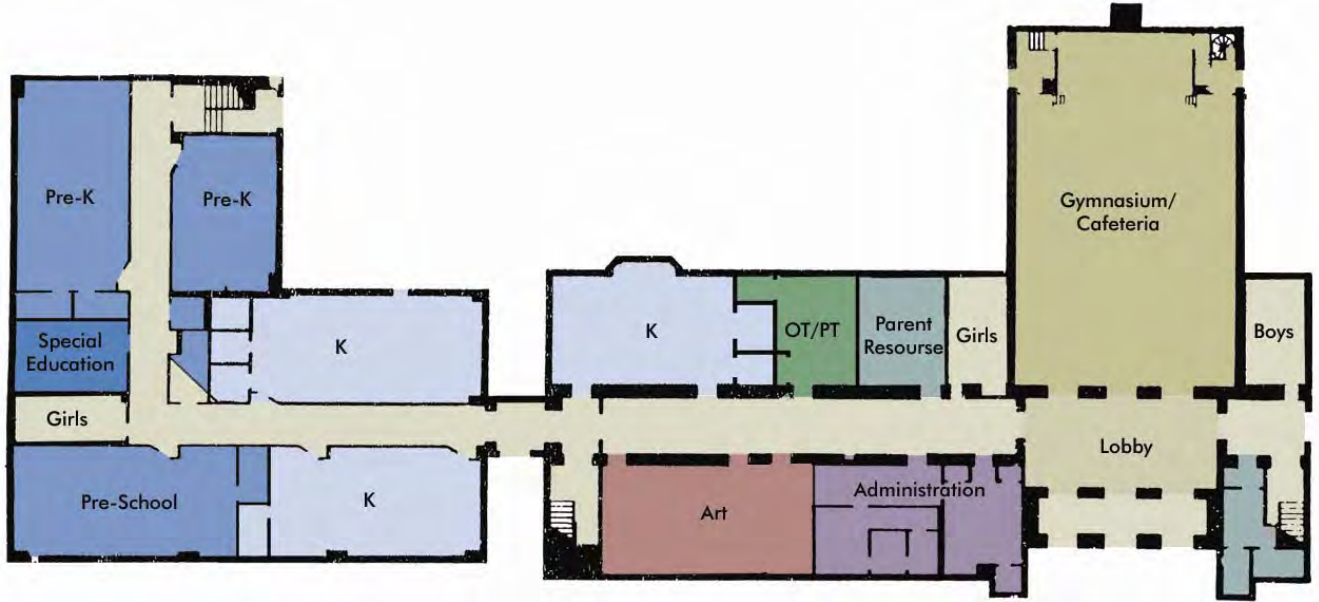
First Floor

These floor plans represent planning concepts for proposed facility use, aligning the proposed program capacity, the proposed planning profiles, and the conceptual reconfiguration of the building. Each project is subject to a formal design process, incorporating input from the School Improvement team at the time of project initiation.

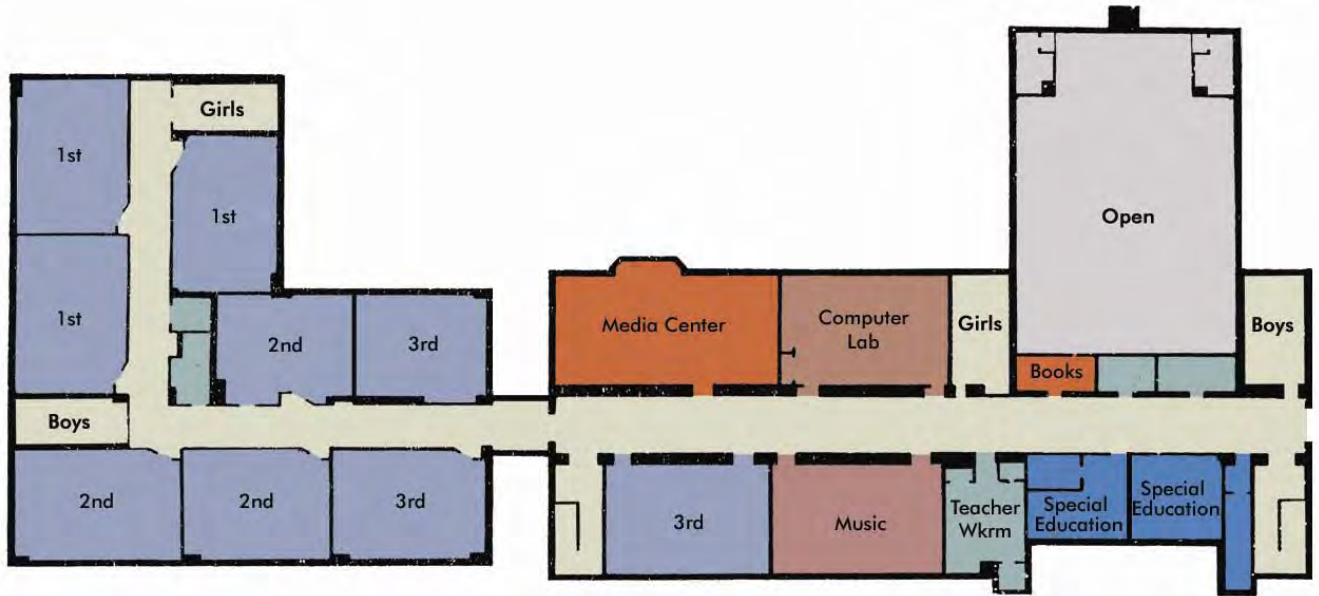
Second Floor

These floor plans represent planning concepts for proposed facility use, aligning the proposed program capacity, the proposed planning profiles, and the conceptual reconfiguration of the building. Each project is subject to a formal design process, incorporating input from the School Improvement team at the time of project initiation.
