WILSON, J.O. ELEMENTARY SCHOOL

660 K Street, N.E., Washington, D.C.

CONDITION ASSESSMENT

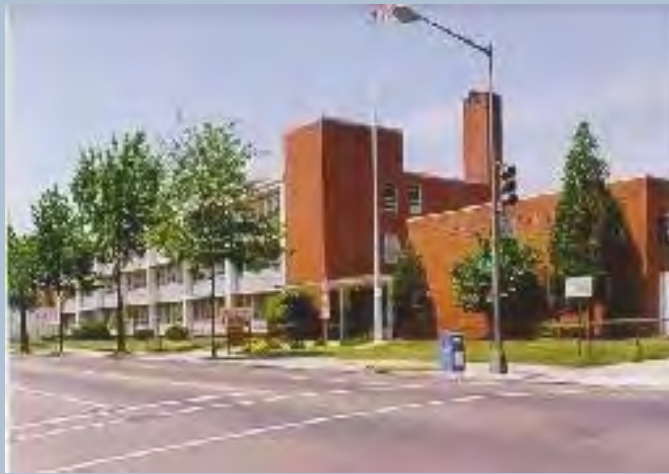
Building System	2008 Rating
ADA Compliance	Unsatisfactory
Conveying Systems	Unsatisfactory
Electrical	Unsatisfactory
Exterior Finish	Fair
HVAC	Poor
Interior Finish	Fair
Plumbing	Poor
Roof	Fair
Structure	Fair
Technology	Good

1 Conveying System	There are no lifts, elevators, or escalators present.
2 Electrical	The lighting in the building needs a total rehabilitation. Most of the classrooms don't meet the recommended foot candle level. The fire alarm system needs to be modified to be brought up to current standards and a preventative maintenance program needs to be implemented on all the equipment to help extend the service life.
3 Exterior Finish	Exterior brick and concrete appear to be in fair condition overall. Routine maintenance such as re-pointing and sealing are recommended. 2007: Replaced exterior lighting.
4 Structure	No major deficiencies were observed. Minor cracking consistent with concrete frames was seen.
5 HVAC	All the boiler room equipment needs to be replaced. The classrooms are currently being cooled by ceiling mounted air handling units that don't get the proper maintenance and are past life expectancy. In the new addition, built just a few years ago, there are many pieces of HVAC equipment and plumbing fixtures that are much older. Even though the new addition is a few years old, all the baseboard heaters should reach the end of useful service life within five years. 2008: Repairs to boilers and classroom units. Repairs to AC Central Unit.

6 Interior Finish	Sections of flooring should be replaced with new carpet and/or vinyl tiles. Ceiling tiles are damaged and should be replaced with new.
7 Plumbing	Plumbing fixtures in the new addition are not new and do not appear to have been installed new. They will reach the end of useful service life in about five years as well. Additional ADA compliant fixtures should be installed throughout the building.
8 Roof	There was standing water on the roof of the new addition also. This will lead to premature roof failure. More roof drains need to be added and weren't considered after the roof top air handling units were installed.
9 ADA Compliance	Currently there aren't any elevators or ramps, and only a few bathrooms which meet ADA requirements. Issues exist with access, alarms, various fixtures and switches, and handrails.
10 Technology	Visual inspection is a limited tool for technology assessments. Generally, the equipment observed appears to be in fair condition. Upgrades should include software, networking, and climate controlled spaces to house equipment.

11 Grounds	The grounds are in fair to poor condition. Curb cuts should be added and general maintenance performed to seal concrete to prevent cracking and spalling.
