# ELIOT-HINE MIDDLE SCHOOL

1830 Constitution Avenue, N.E., Washington, DC

<b>INITIAL YEAR BUILT</b>	1931
<b>BUILDING AREA</b>	155,100 SF
<b>CURRENT PROGRAM CAPACITY</b>	850
<b>ENROLLMENT 2008</b>	258
<b>WARD</b>	6
<b>PROPOSED PROGRAM CAPACITY</b>	450

## CONDITION ASSESSMENT

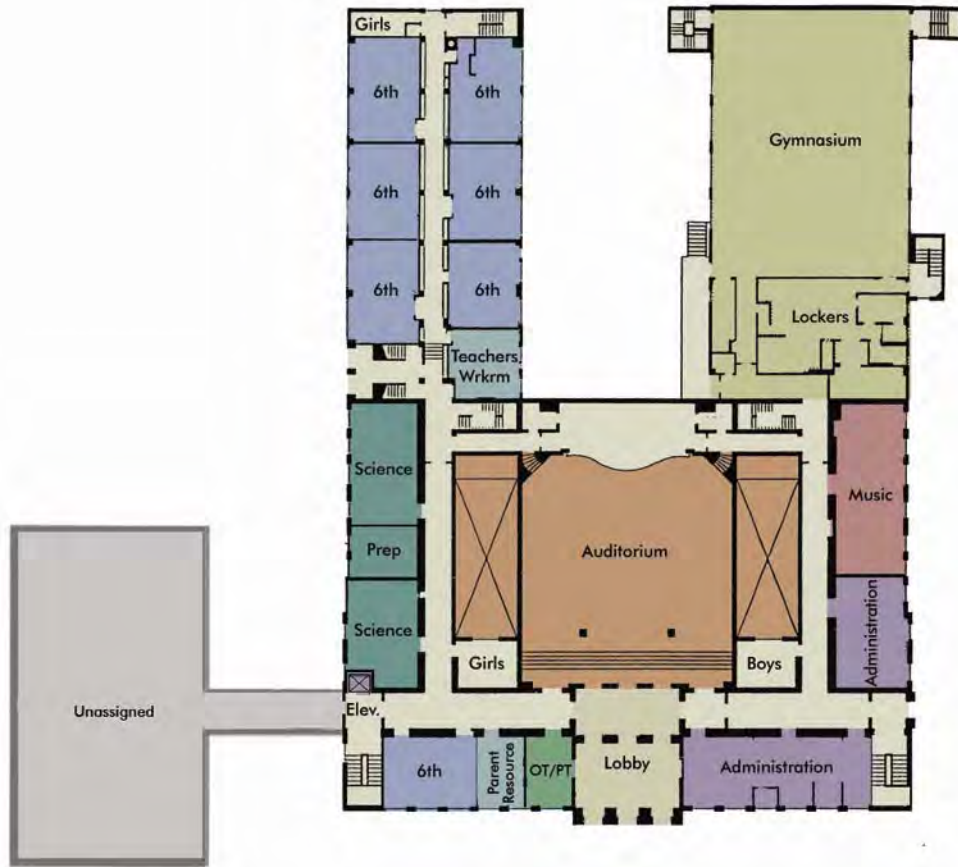
First Floor

These floor plans represent planning concepts for proposed facility use, aligning the proposed program capacity, the proposed planning profiles, and the conceptual reconfiguration of the building. Each project is subject to a formal design process, incorporating input from the School Improvement team at the time of project initiation.

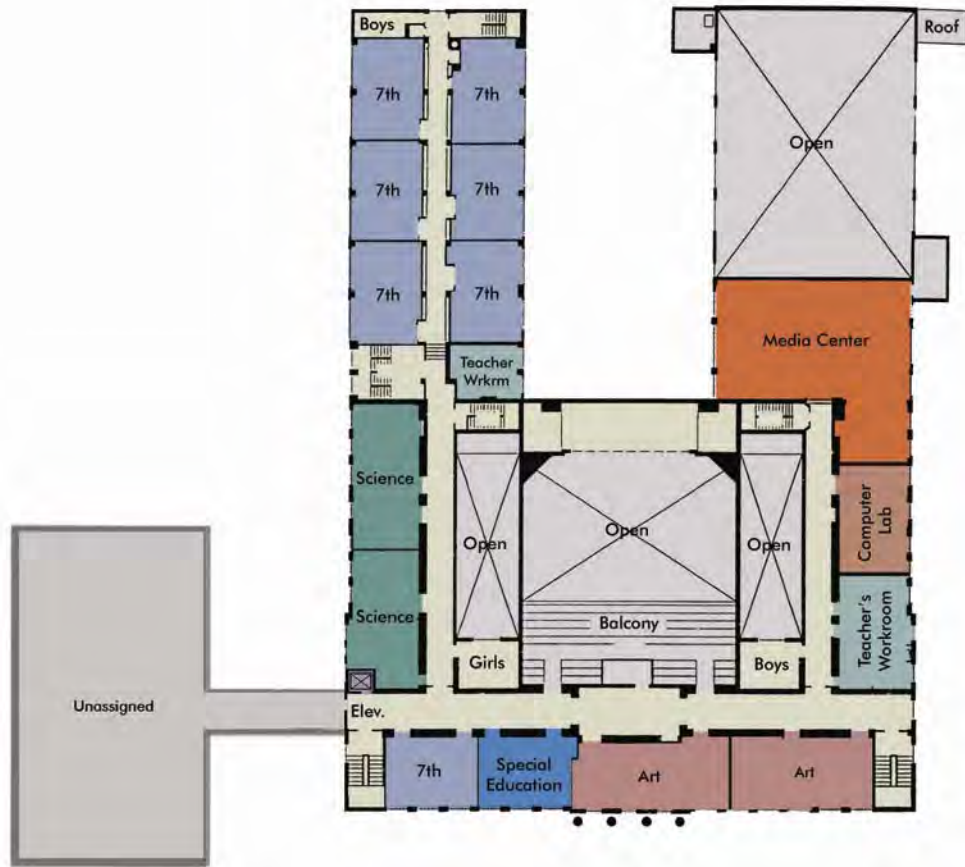
Second Floor

These floor plans represent planning concepts for proposed facility use, aligning the proposed program capacity, the proposed planning profiles, and the conceptual reconfiguration of the building. Each project is subject to a formal design process, incorporating input from the School Improvement team at the time of project initiation.

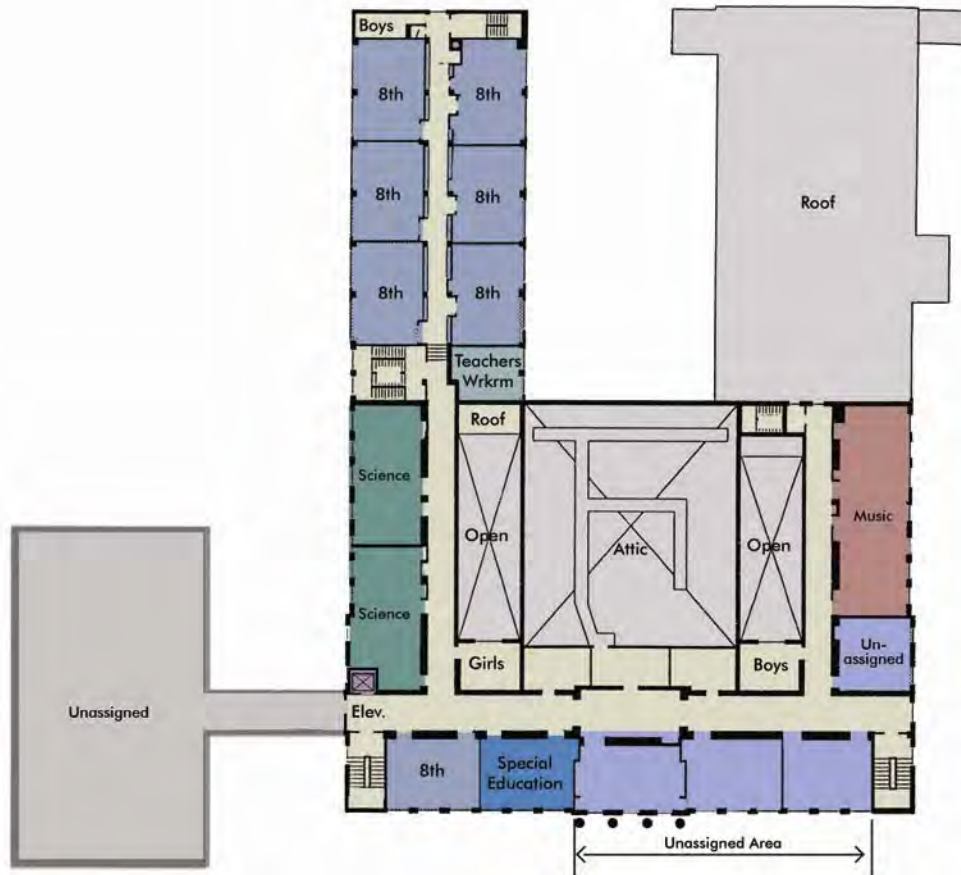
Third Floor

These floor plans represent planning concepts for proposed facility use, aligning the proposed program capacity, the proposed planning profiles, and the conceptual reconfiguration of the building. Each project is subject to a formal design process, incorporating input from the School Improvement team at the time of project initiation.
