ELLINGTON HIGH SCHOOL

1698 35th Street, N.W., Washington, D.C.

CONDITION ASSESSMENT

Condition Assessment

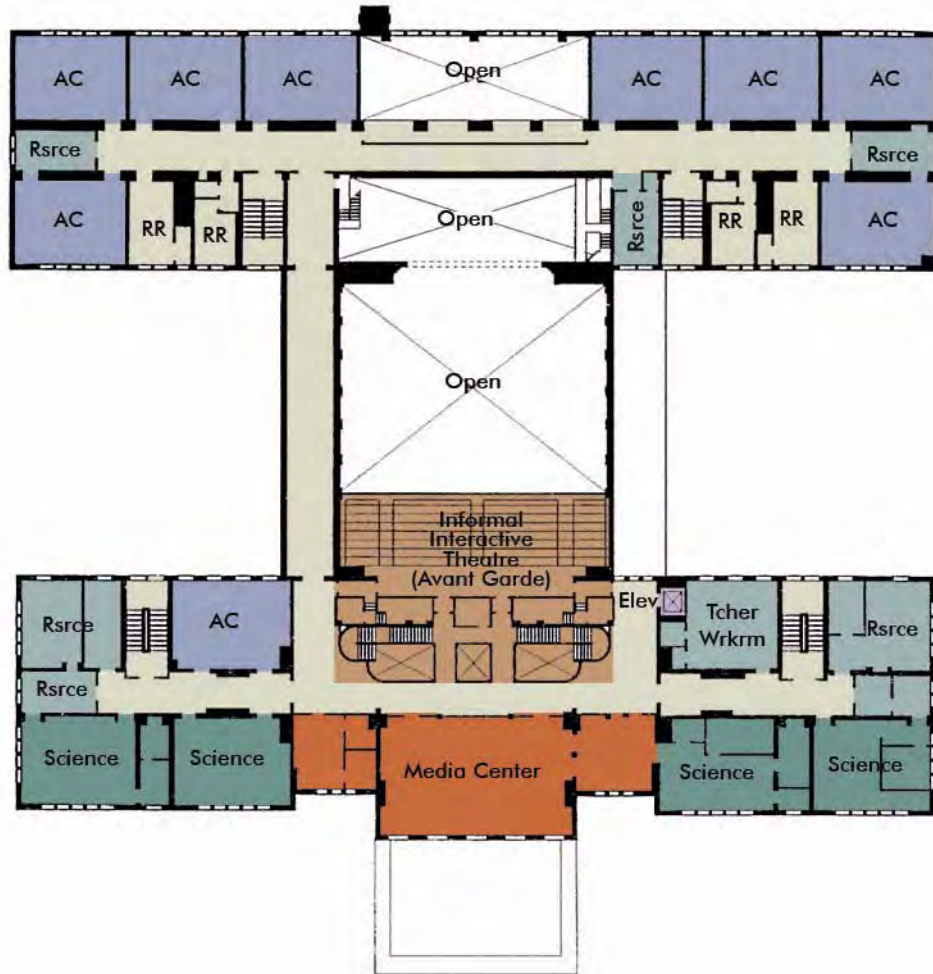
Second Floor

These floor plans represent planning concepts for proposed facility use, aligning the proposed program capacity, the proposed planning profiles, and the conceptual reconfiguration of the building. Each project is subject to a formal design process, incorporating input from the School Improvement team at the time of project initiation.
