4400 Brooks Street, N.E., Washington, DC

### PROPOSED PROGRAM PROFILE

### **CONDITION ASSESSMENT**

#### **Concept Plans**

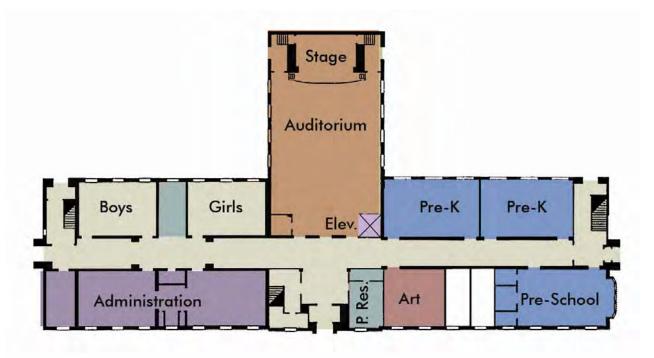
First Floor

Administration/Health Auditorium Gymnasium/Cafeteria Other Classrooms Media Center Kindergarten Computer Lab Pre-K/Pre-School OT/PT Music/Art Special Education Science Lab Unassigned Lobby **Elevator Addition**

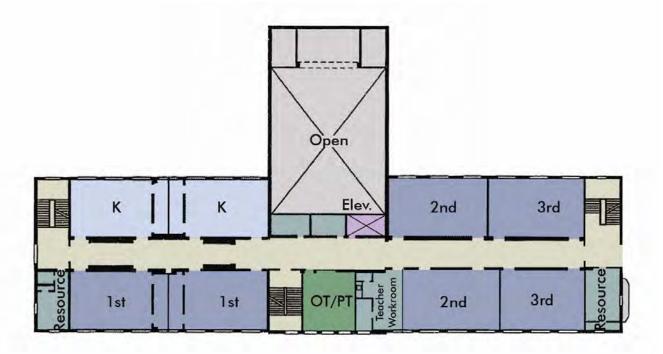
Second Floor

Administration/Health Auditorium Gymnasium/Cafeteria Other Classrooms Media Center Kindergarten Computer Lab Pre-K/Pre-School OT/PT Music/Art Special Education Science Lab Unassigned Lobby Elevator Addition
