# MAURY ELEMENTARY SCHOOL

1250 Constitution Avenue, N.E., Washington, DC

### Proposed Planning Profiles

## CONDITION ASSESSMENT

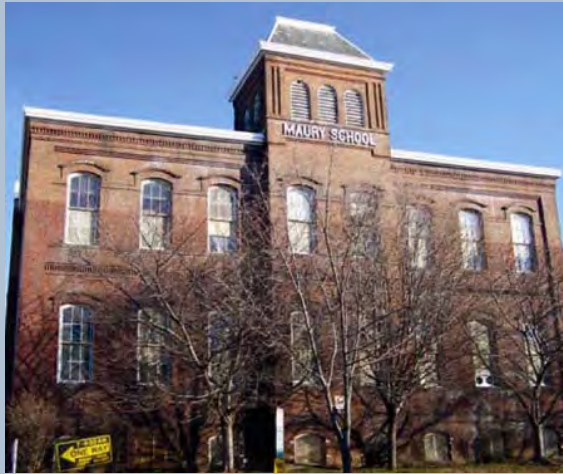
<i>Building System</i>	<i>2008 Rating</i>
ADA Compliance	Unsatisfactory
Conveying Systems	Unsatisfactory
Electrical	Poor
Exterior Finish	Unsatisfactory
HVAC	Poor
Interior Finish	Fair
Plumbing	Poor
Roof	Fair
Structure	Fair
Technology	Poor

<b>1 Conveying System</b>	There is no escalator, lift, or elevator in the building.
<b>2 Electrical</b>	Original equipment in poor condition. Electrical cables and wiring are over forty years old. There is no emergency generator. The fire alarm system is not code compliant. Lighting is generally in fair condition but not particularly energy efficient.
<b>3 Exterior Finish</b>	Windows are in poor condition and not operable; single pane and need replacement. Brickwork in fair condition and in need of sporadic repointing or other minor repair work. Exterior doors need to be repaired or replaced. <b>2007: Replaced Exterior Lighting.</b>
<b>4 Structure</b>	Exterior structure is in fair condition. Repainting and masonry repairs needed in areas.
<b>5 HVAC</b>	Ventilation and exhaust systems in building are not operational. Cooling by window units in many cases is unsatisfactory as the units are in poor condition. Visible ductwork in poor condition and should be replaced. <b>2007: Heating Plant Upgrades. 2008: Repairs to boiler(s) and Classroom heating units. Installed 2 AC Window Units. Service to HVAC units has been completed. AC unit replacements also completed.</b>

<b>6 Interior Finish</b>	Asbestos floor tiles throughout represents potential health safety issue. Interior finishes are worn. Isolated areas of walls and ceilings require patching and repainting. <b>2007: Replace ceiling tiles completed, flooring, plaster repair, and painting completed.</b>
<b>7 Plumbing</b>	No sprinkler system in 1961 portion. Hot water system valves and pump need replacement. Fixtures are outdated and not code compliant. Drinking fountains should also be replaced. <b>2007: Plumbing completed.</b>
<b>8 Roof</b>	Portions of the building roofing are in poor condition and need replacement. Membranes, slate, and metal seams are all used for roofing materials and all require some manner of repair. Flashing and gutters should be maintained to a higher standard.

<b>9 ADA Compliance</b>	Building does not meet ADA code requirements. A few deficiencies are: conveying, access, fixtures and alarms.
<b>10 Technology</b>	Little to no technology was observed. Visual inspection is a limited tool for technology assessments. Upgrades should include software, hardware, networking, and a climate controlled environment to house the equipment.
<b>11 Grounds</b>	Parking lot needs repaving or resurfacing. The playground needs repaving as well.

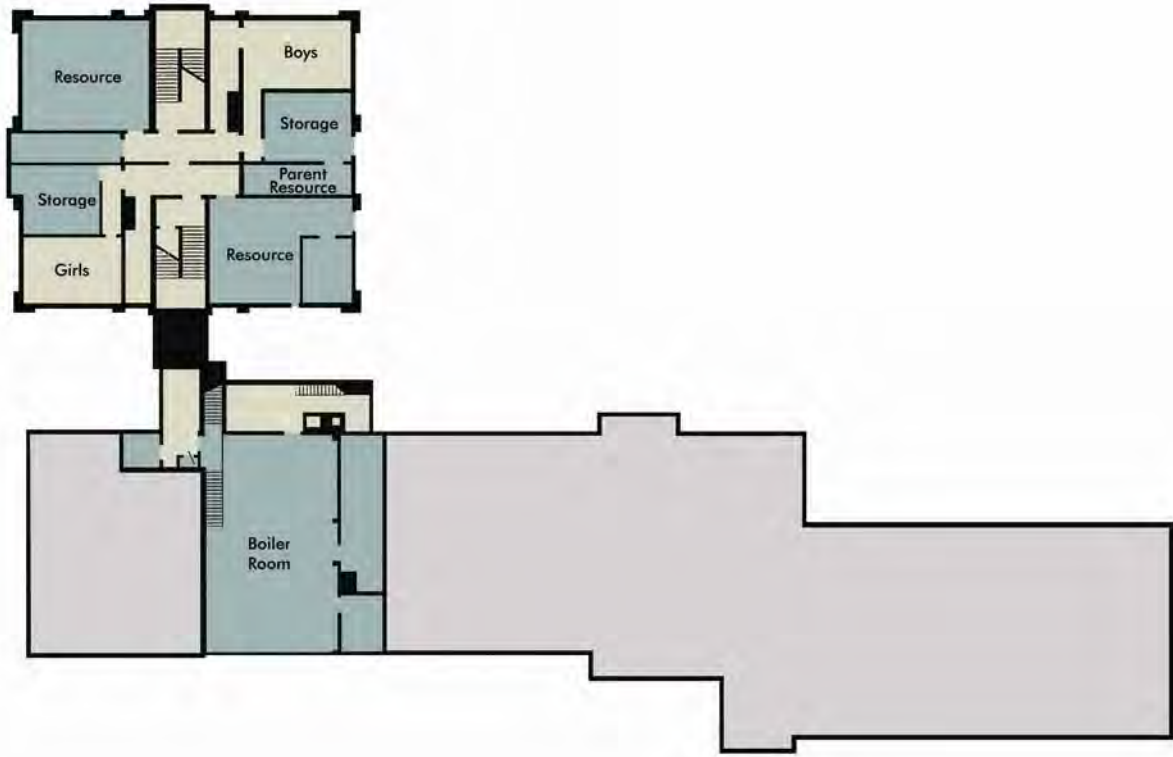
Basement

### Concept Plans

These floor plans represent planning concepts for proposed facility use, aligning the proposed program capacity, the proposed planning profiles, and the conceptual reconfiguration of the building. Each project is subject to a formal design process, incorporating input from the School Improvement team at the time of project initiation.

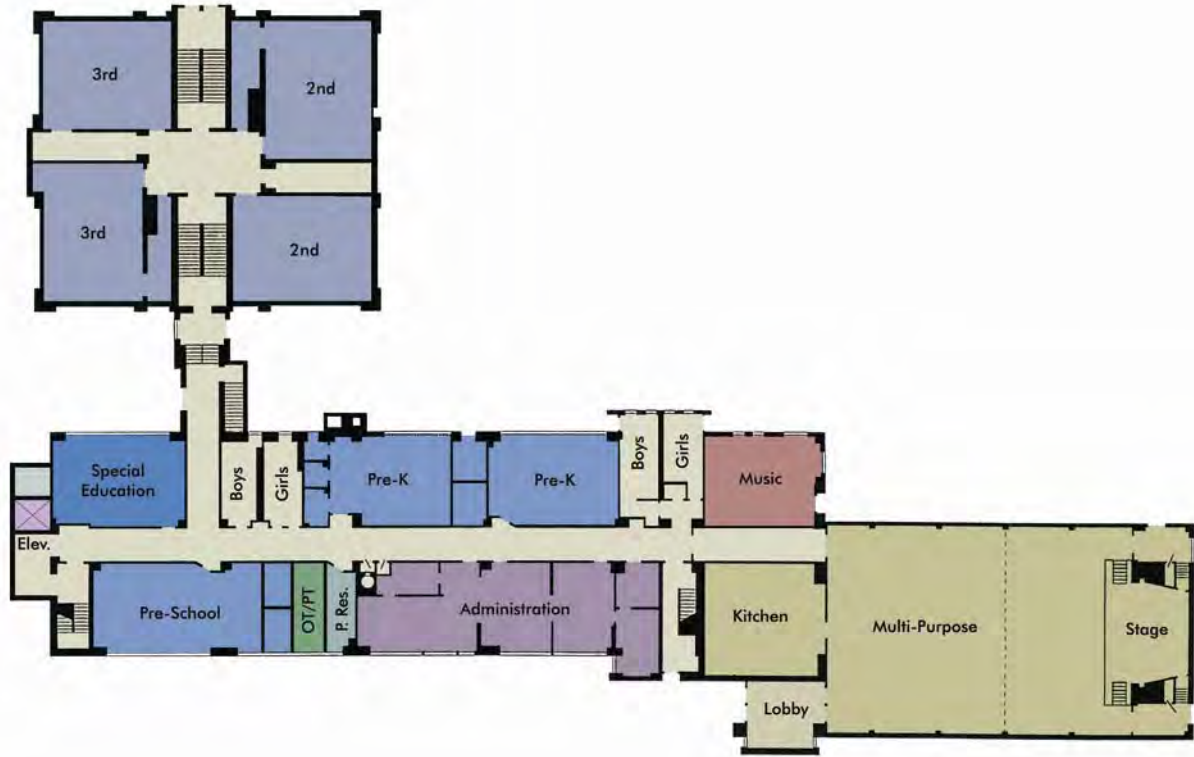
First Floor

### Concept Plans

These floor plans represent planning concepts for proposed facility use, aligning the proposed program capacity, the proposed planning profiles, and the conceptual reconfiguration of the building. Each project is subject to a formal design process, incorporating input from the School Improvement team at the time of project initiation.

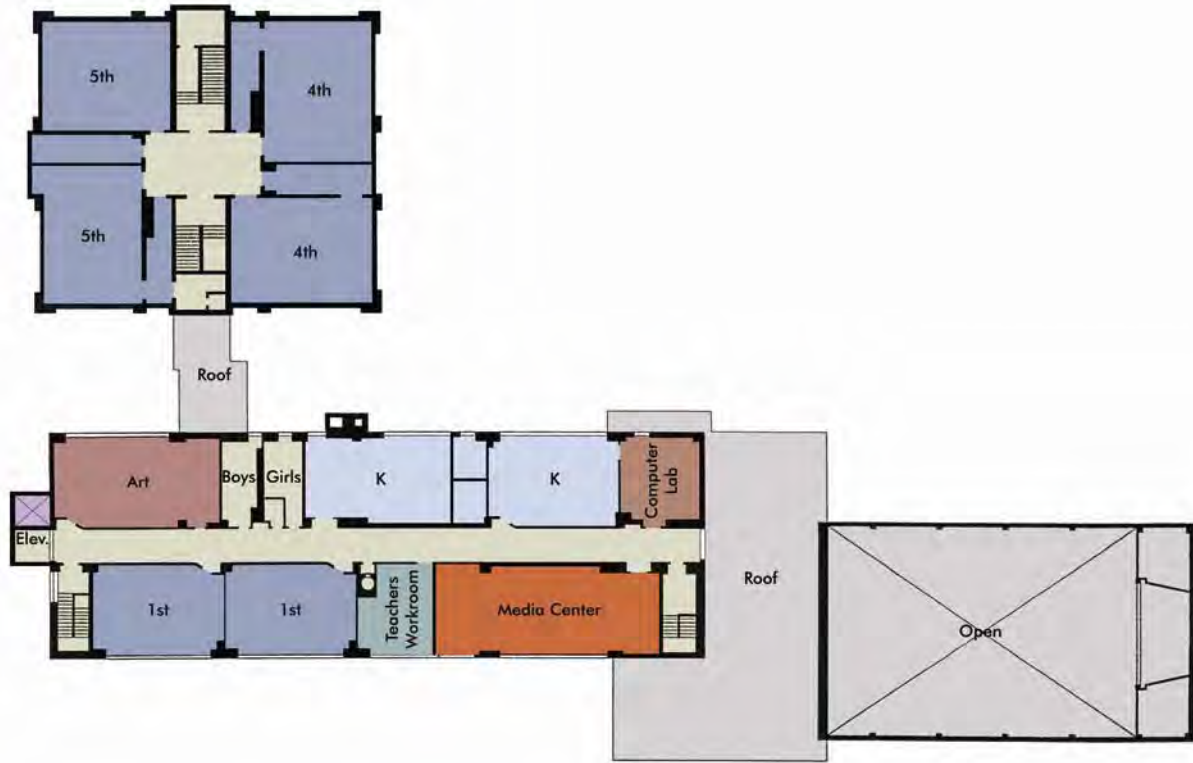
Second Floor

### Concept Plans

These floor plans represent planning concepts for proposed facility use, aligning the proposed program capacity, the proposed planning profiles, and the conceptual reconfiguration of the building. Each project is subject to a formal design process, incorporating input from the School Improvement team at the time of project initiation.
